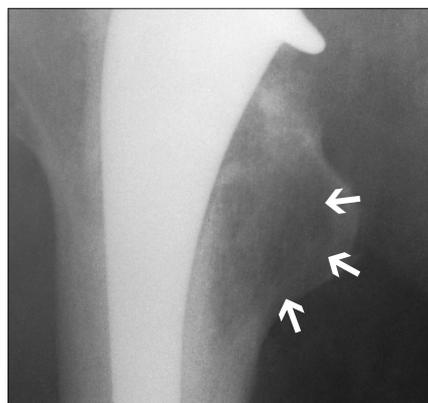
In our case the implant used was titanium. From an early stage a radiolucent line was seen between the prosthesis and the cement in zones 1 and 7. This gap on supine x-ray films may have been due to bending of the prosthesis, flow in the cement or tapping of wear debris pumped into the gap during cyclical loading (Fig. 8). Cyclical bending of the prosthesis obviously occurred, as evidenced by the burnishing of the prosthesis on either side of the ultimate prosthetic fracture. Cyclical bending of a distally fixed prosthesis, resulted in fatigue failure as the degree of deflection was above the fatigue threshold. Given

FIG. 8. Radiograph showing wear debris.
