# Analysis of a school bus collision: mechanism of injury in the unrestrained child

Peter C. Lapner, MD; Duong Nguyen, MD; Mervyn Letts, MD

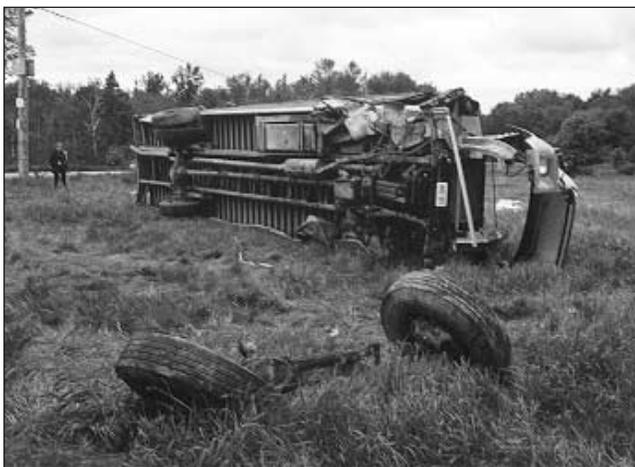
The crash occurred at the intersection of 2 undivided 2-lane roads. The posted speed limit was 80 km/h. The truck ran the stop sign at full speed and collided with the left front wheel of the bus. The bus rotated clockwise, then rolled down an embankment, struck a rock pile, and continued to roll over another 2½ times before coming to rest on its left side (Fig. 1). Passengers were all thrown toward the left side of the bus.

FIG. 1. Structural damage to front end and axle of bus in its final resting place.

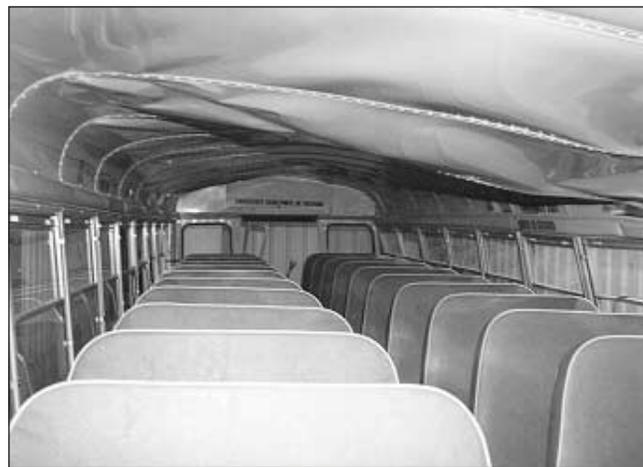
Examination of bus structure showed that roof intrusion was concentrated over rows 1–6 (mostly over rows 1–4), with maximum intrusion of 26 cm over row 4 (Fig. 2). All side windows were intact. The windshield

FIG. 2. The site of maximal roof intrusion lies toward the front of the bus cage.

In the compartmentalization model, protection exists in the event of head-on or rear-end collisions. However, little protection exists along the sides of the compartment over window headers and on panelling between windows. Extra padding in these areas would be helpful to minimize direct-impact trauma.

Although we agree with the principle of compartmentalization, changes to the structure of the compartment by extending the padding to the sides, over the window headers and on the panelling between the windows, would minimize the number and severity of injury seen in this common type of bus crash.
