Pneumothorax following tube thoracostomy and water seal drainage

Tube thoracostomy connected to a chest drainage system is a common procedure in children for the management of pleural effusion. However, it is quite unusual for pneumothorax to occur subsequently in the absence of a pulmonary lesion. We report such a case, which led to numerous superfluous interventions before the true cause was recognized.

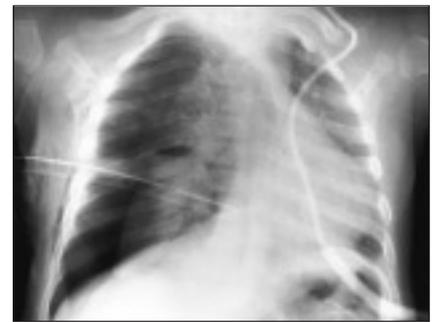
FIG. 1. Chest film obtained on postoperative day 29 shows the right pneumothorax.

On day 27, the pleural effusion reappeared, without pneumothorax. A central venous catheter and a new chest tube were installed under general anesthesia. From this day on, the pneumothorax was intractable (Fig. 1), necessitating numerous manipulations, changes of tube, increases in suction (up to -30

cm H₂O) and placement of a second tube on postoperative day 31, all without success. When the child cried, negative pressure went high in the water seal chamber, even reaching the high negativity float valve. On day 31, the nursing staff noted for the first time that the high negativity relief valve was used to vent excessive negativity. When use of this valve was prohibited, the pneumothorax progressively disappeared and never recurred.
